Meniscus Tears

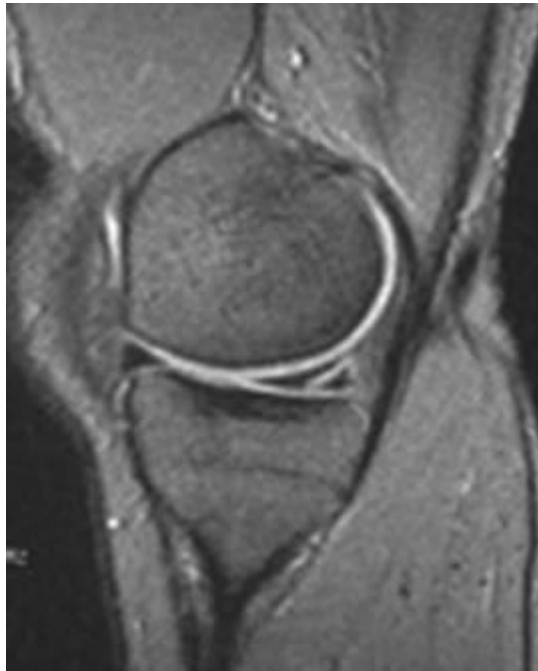
Tears of the meniscus are common injuries seen in the knee. They can occur anywhere along the meniscus. The clinically relevant tear where the meniscus is torn through is sometimes referred to on MRI reports as a Type III meniscus. The tear can be seen on both the sagittal and coronal slices. Tears are easiest to identify on the water weighted sequences (where water is white) such as T2, STIR, Fat Suppression, et cetera. The tear will show up as a linear band of high signal.

Importantly, it must extend to at least one of the edges of the cartilage like the posterior horn tear seen below. Also, it should be seen on at least two consecutive slices.
